## DISC BRAKE ADJUSTMENT

CHECKING AUTOMATIC ADJUSTMENT

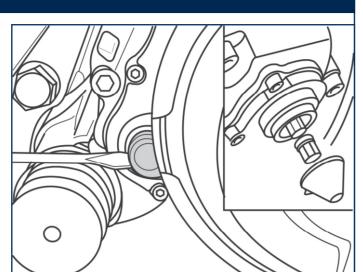
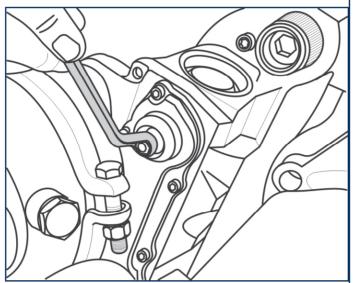
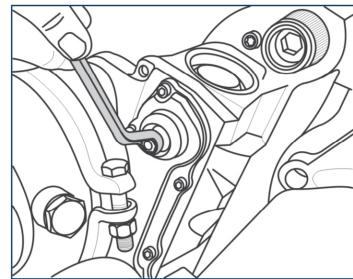
Remove the rubber cap. The old adjuster requires the use of an 8 mm ring spanner. The newer style of 'shear adaptor' type of adjuster requires a 10 mm ring spanner. Turn the adjuster anti-clockwise until 3 or 4 clicks are heard (note that this will not be possible if new pads are fitted).

Apply brake 5 to 10 times (approximately 2 bar). If the adjustment is correct, the ring spanner will turn back in a clockwise direction (make sure the ring spanner can rotate freely).

If the ring spanner moves as described, the adjustment is OK. Remove ring spanner. Apply Renolit HLT2 to the cap and refit.

- a) does not turn
- b) turns only upon initial application
- c) turns forward and back again upon each application

...the adjustment is not correct and the brake caliper must be replaced.

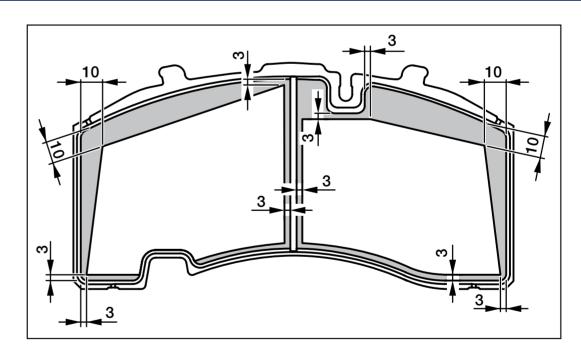
#### RAKE PAD EDGE DEGRADATION

Some edge degradation on the brake pads is allowable, however the pad must be renewed if this exceeds the limits shown in the diagram (above) or accounts for more than 10% of the pad surface.

Edge degradation can be caused by the 'washing effect' that the front and lower edges of the brake pad are subject to during operation. Where this degradation is considered to be a problem, the effect can be minimised by the fitting of covers (BPW part number: 03.010.95.21.0) to the front of the brake caliper.
